Successful Hydrate Remediation in Ultra-Deepwater GOM

James C. Wells
ATP Oil & Gas Corp.

Canyon Express Pipeline System

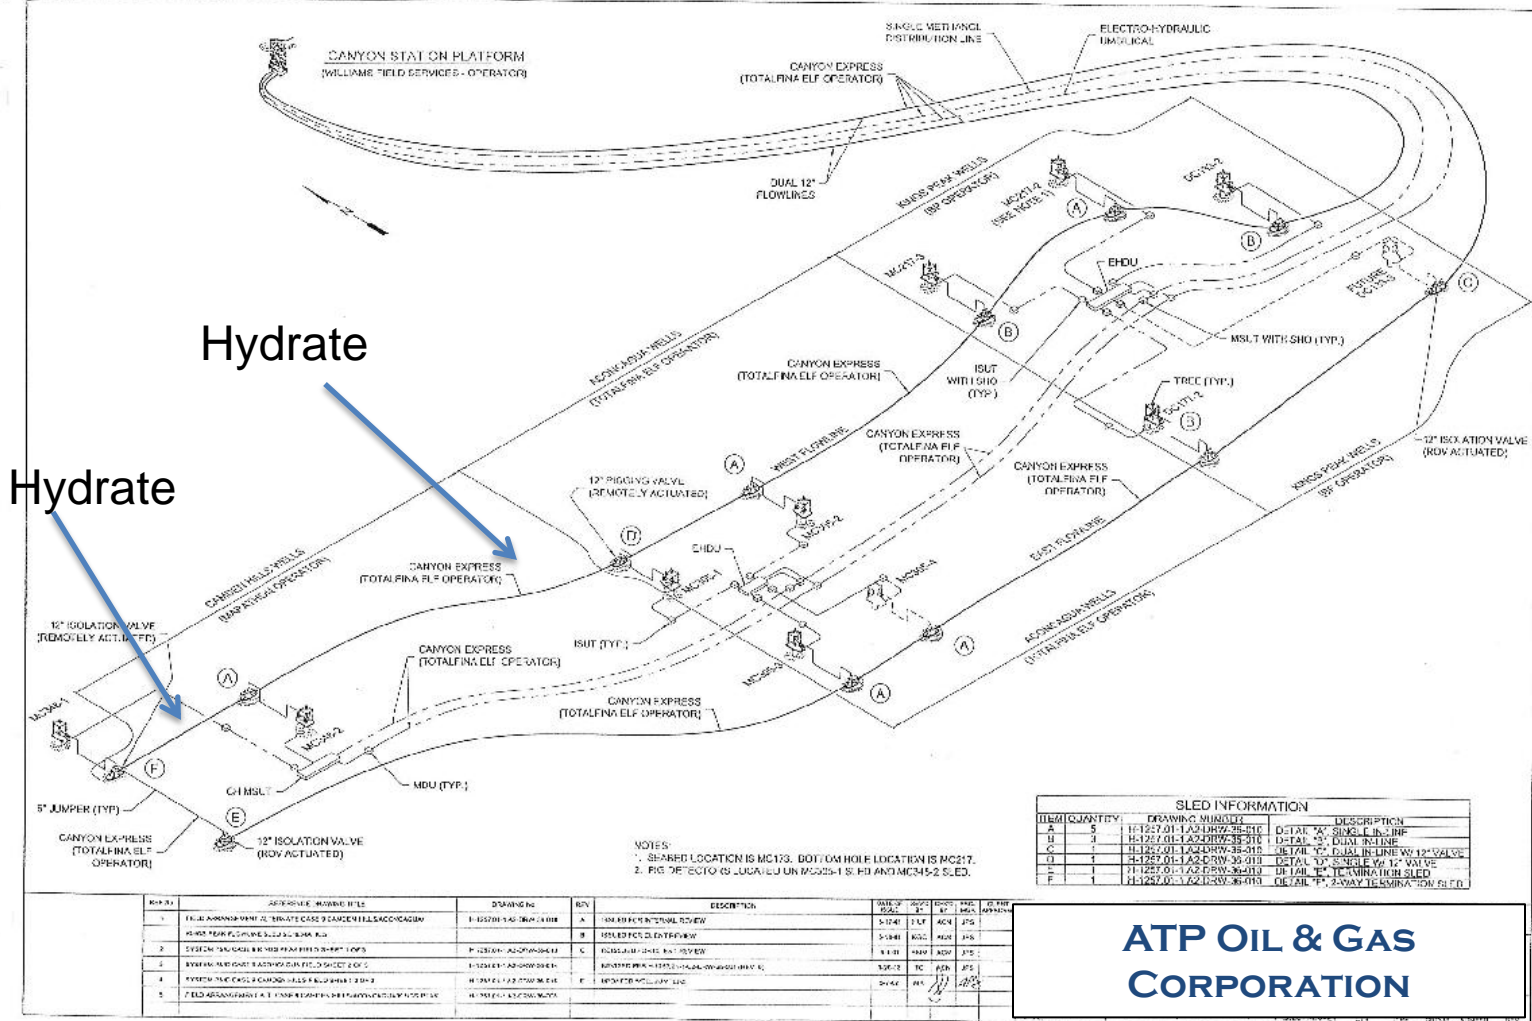
Location of Hydrates

- Determined ESD had shut-in 12” pipeline valve
- Opened 12” pipeline valve
- Large pressure differential remained
- ***HYDRATES HAD FORMED***

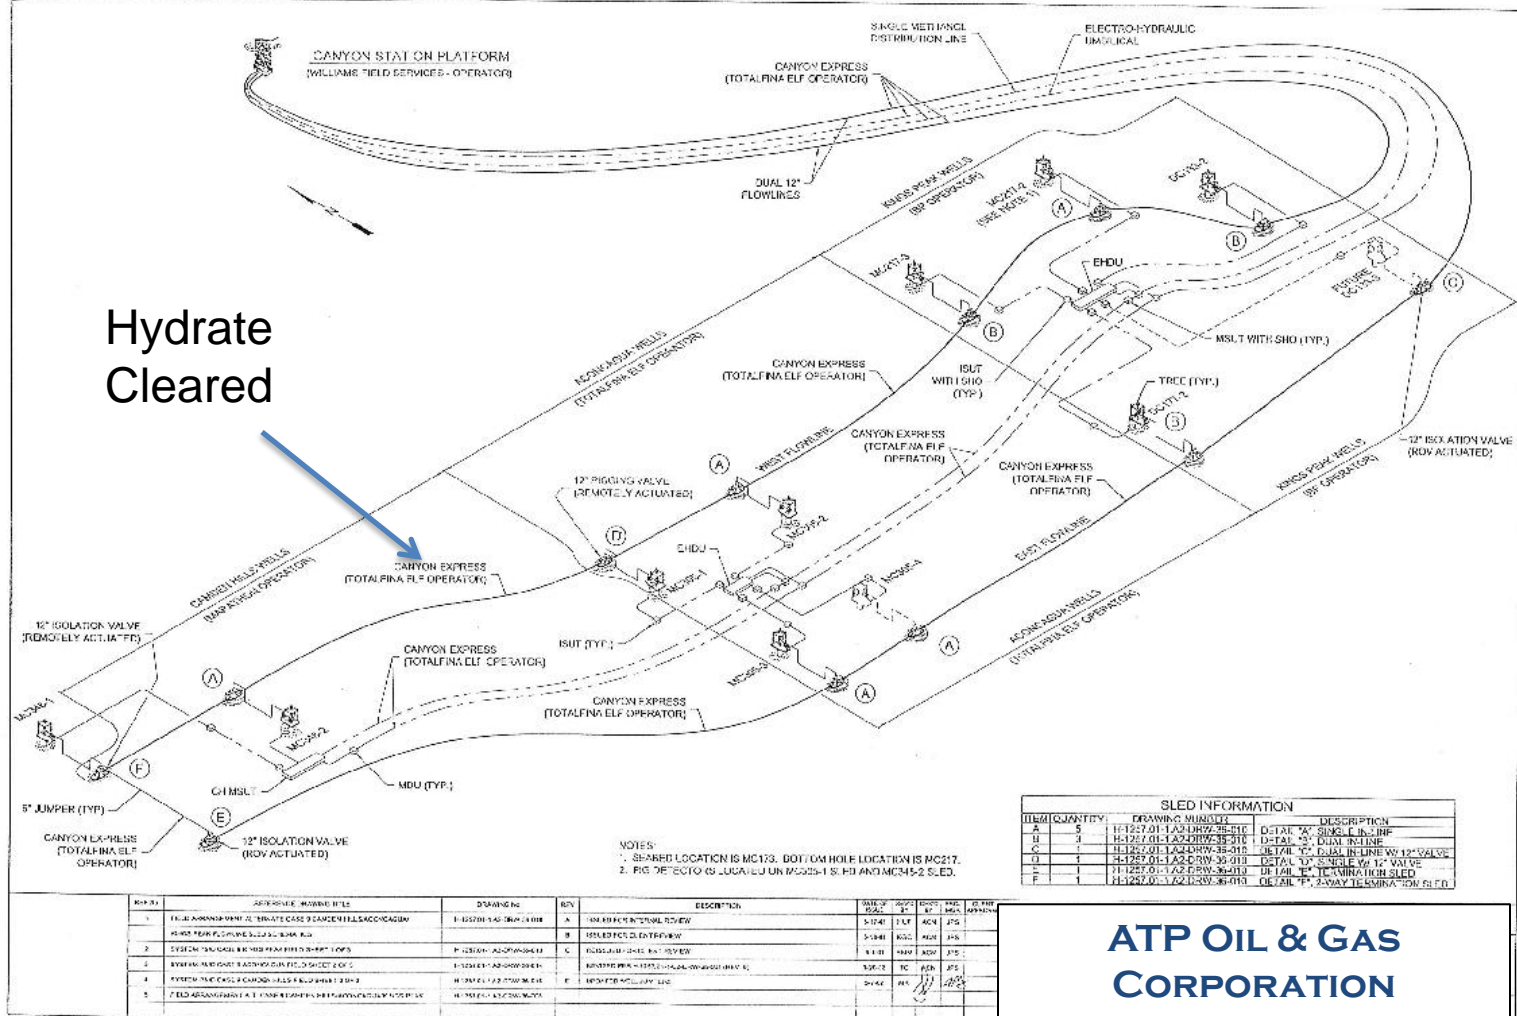
Hydrate Cleared

Hydrate
Cleared

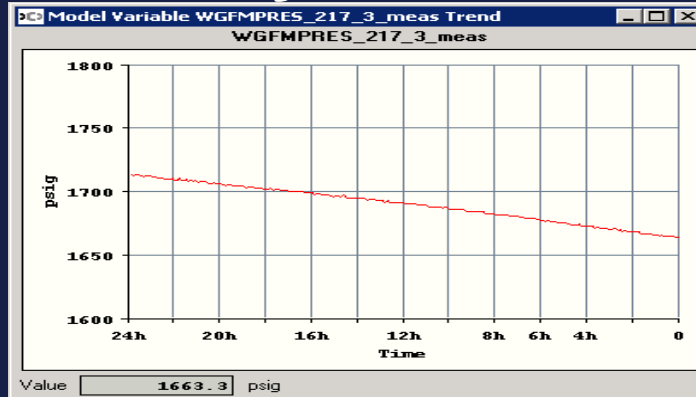
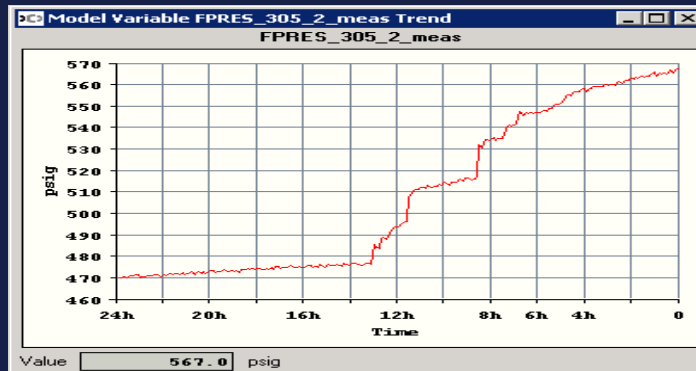
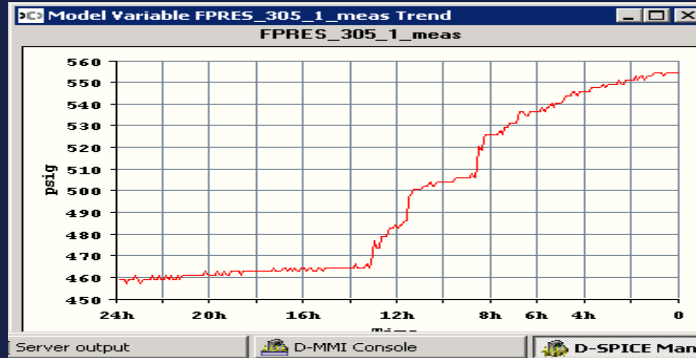
Downtime – Hydrates Still Break
